BRITISH BOARD OF AGRÉMENT ASSESSMENT REPORT Ref: S2/60461

Client: Alumasc Exterior Building Products Ltd

The site inspections detailed in the following report were carried out in order to examine and comment on the performance in use of the Derbigum membranes covered in Certificate 86/1593, regarding appearance, condition & weathering / ageing characteristics etc.

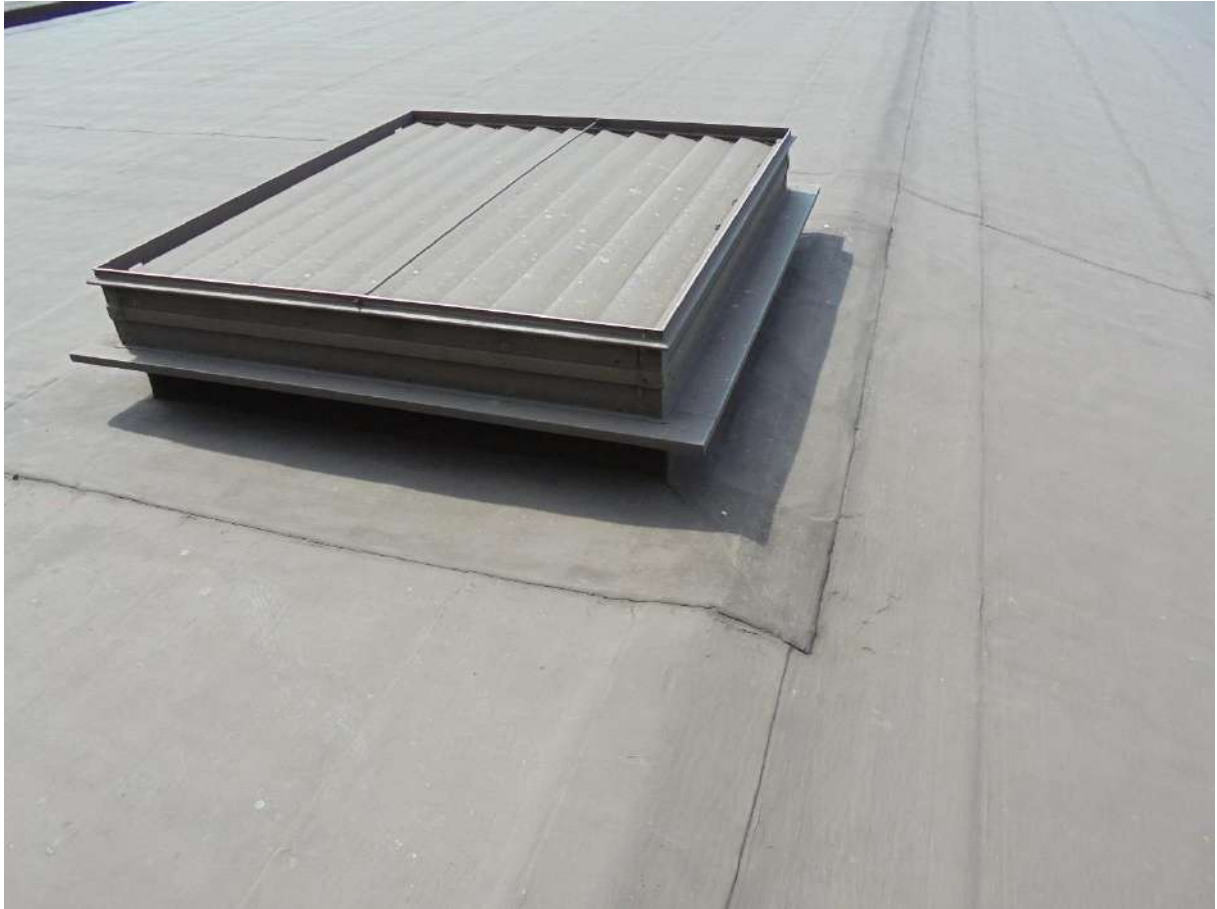
Photo 3 - Site A example of detailing

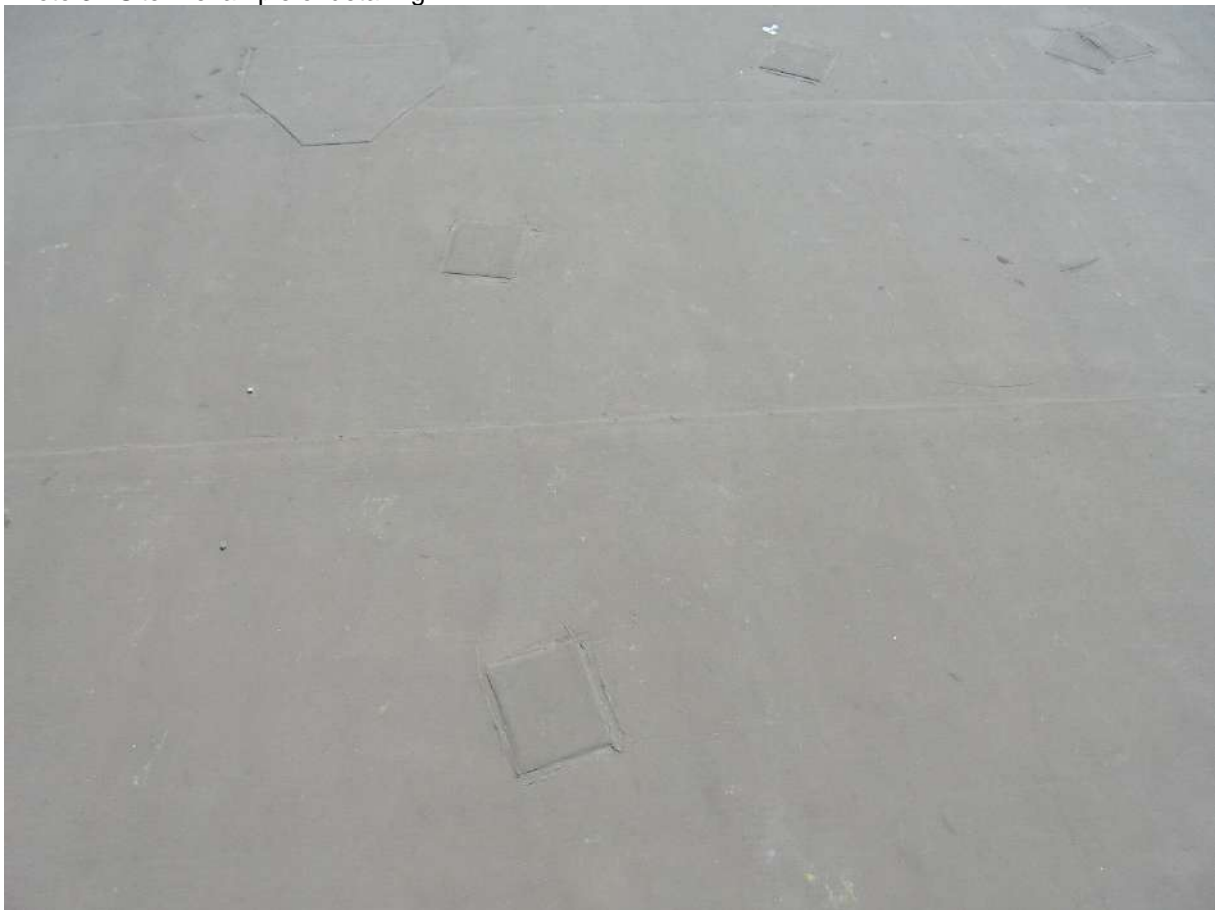
Photo 4 - Site A example of patch repairs

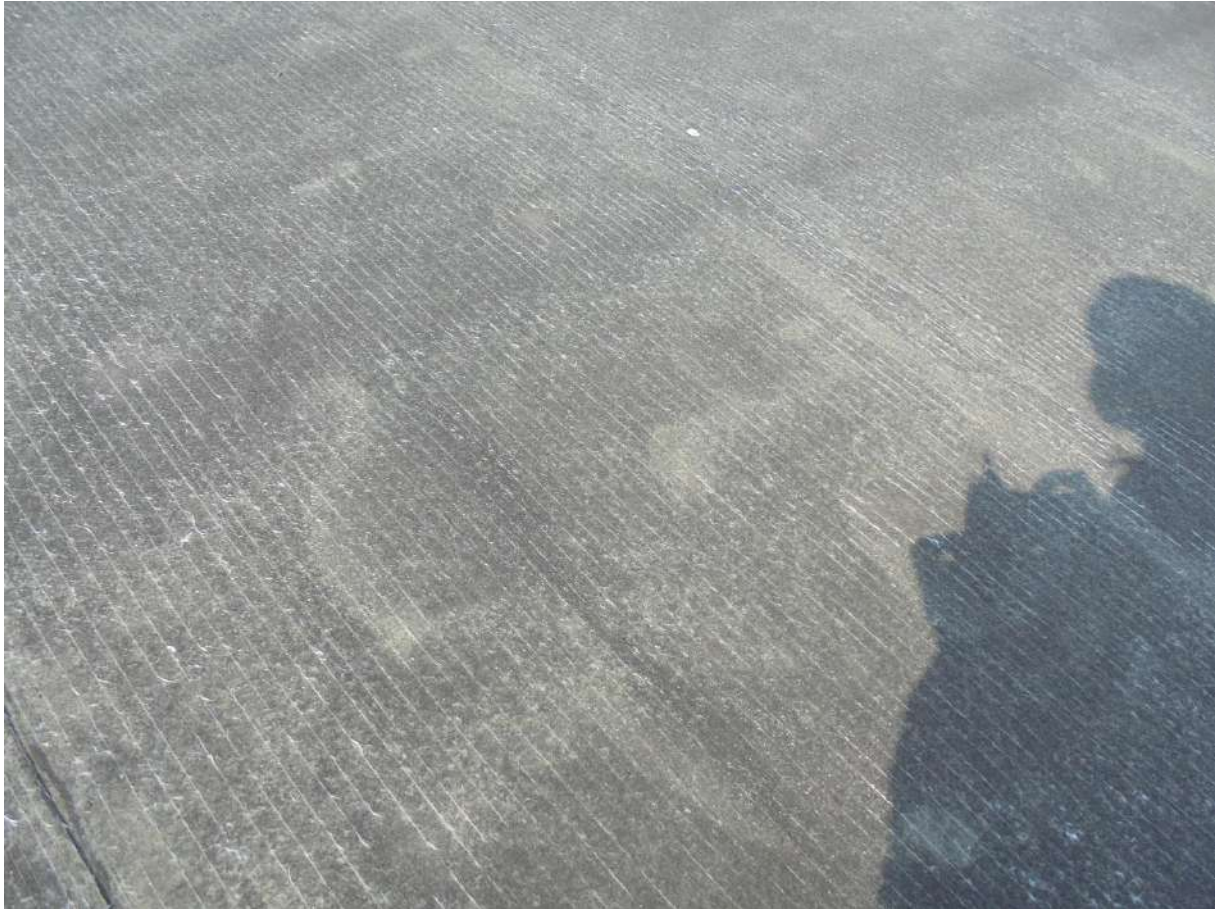
Photo 3 – Top glass reinforcement visible

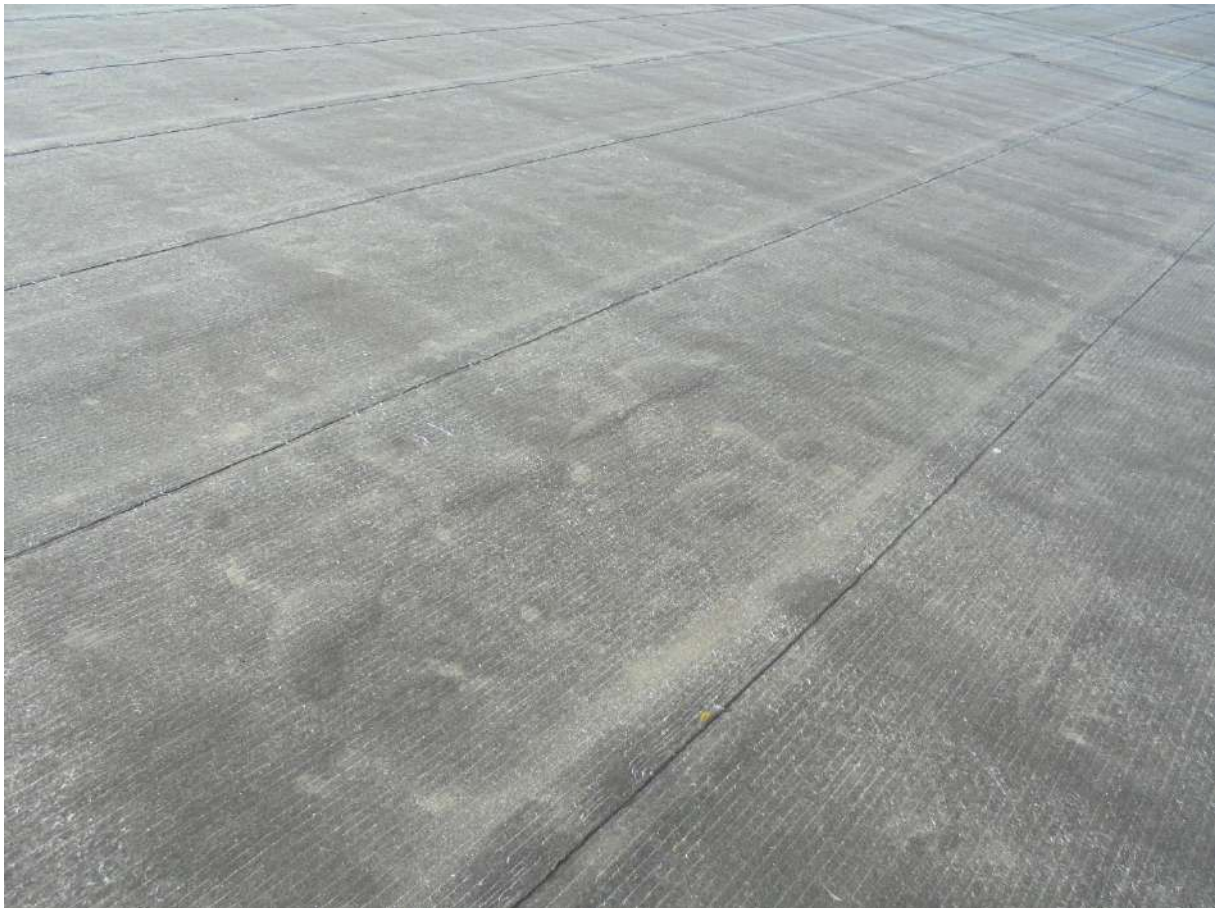
Photo 4- Blistering

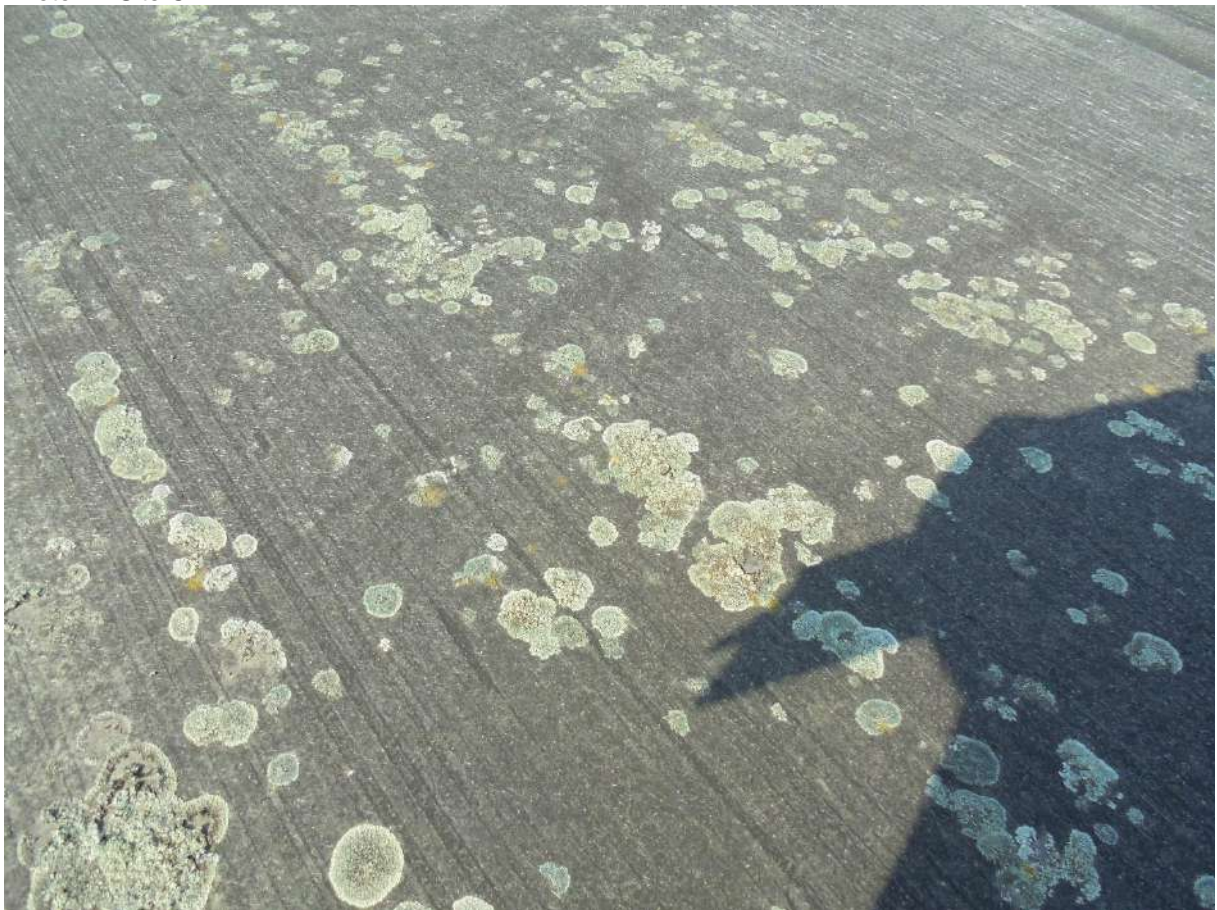
Photo 2 - Site C example of lichen growing on the membrane

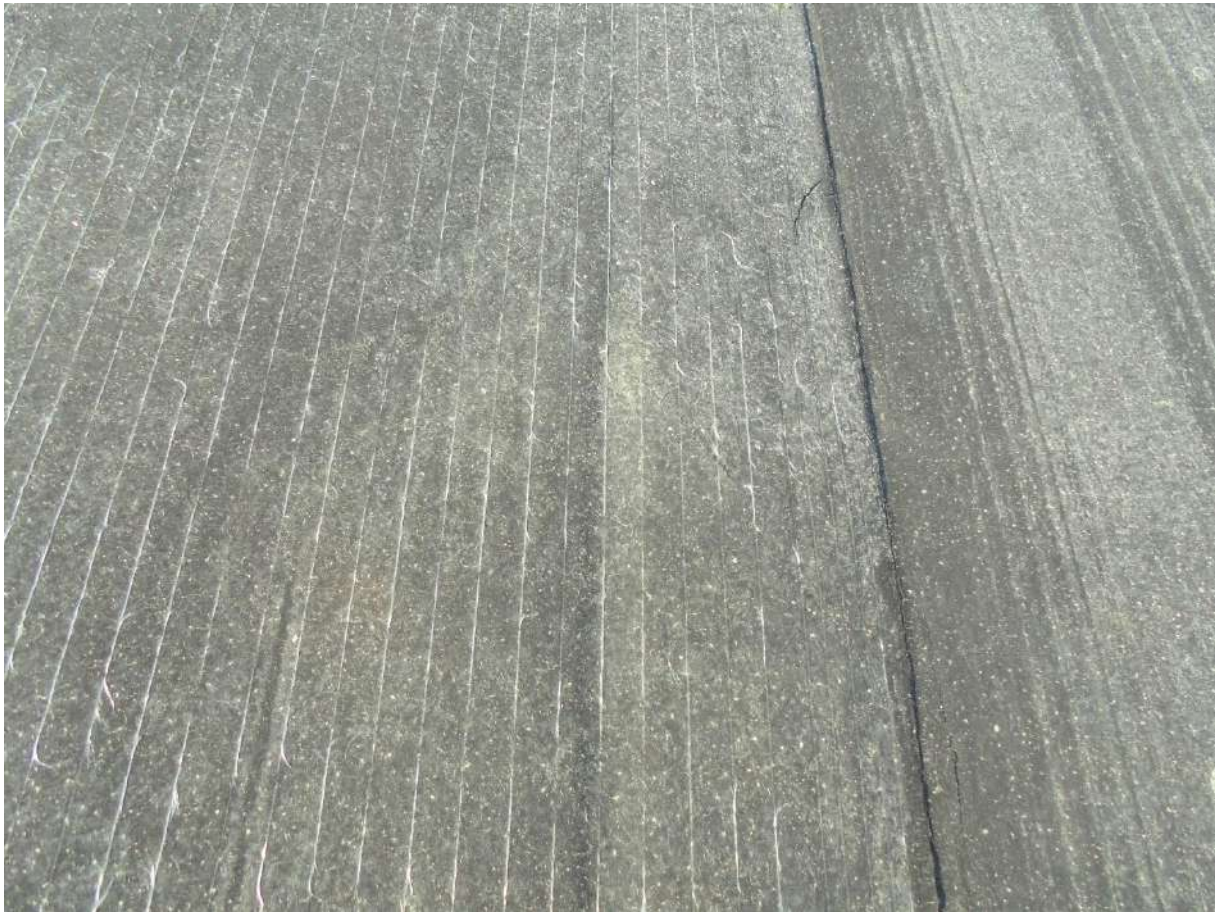
Photo 3 –Site C broken strands of glass reinforcement
