Investigation concerning the long-term behaviour of Polygum roofs in practice

Order No.: 00-B-0111 Ref.: AFVDH/JB

Client: ATAB NV / SA
d'Herbouvillekaai 80
B-2020 Antwerp
Tel.: +32 3 248 30 00
Fax: +32 3 248 37 77
E-mail: polygum.sales@atab.be

Project: Long-term behaviour of Polygum roofs in practice

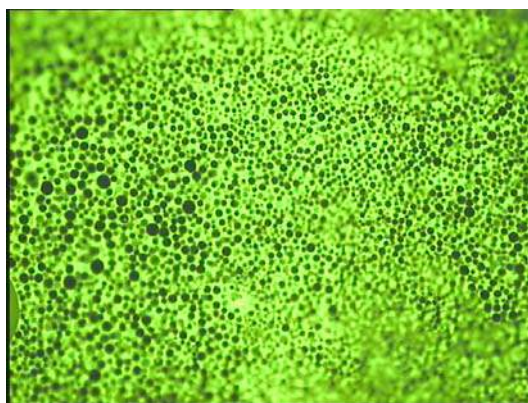
Example of good quality of dispersion.
